Operating Experience Weekly Summary 97-14

March 28 through April 3, 1997

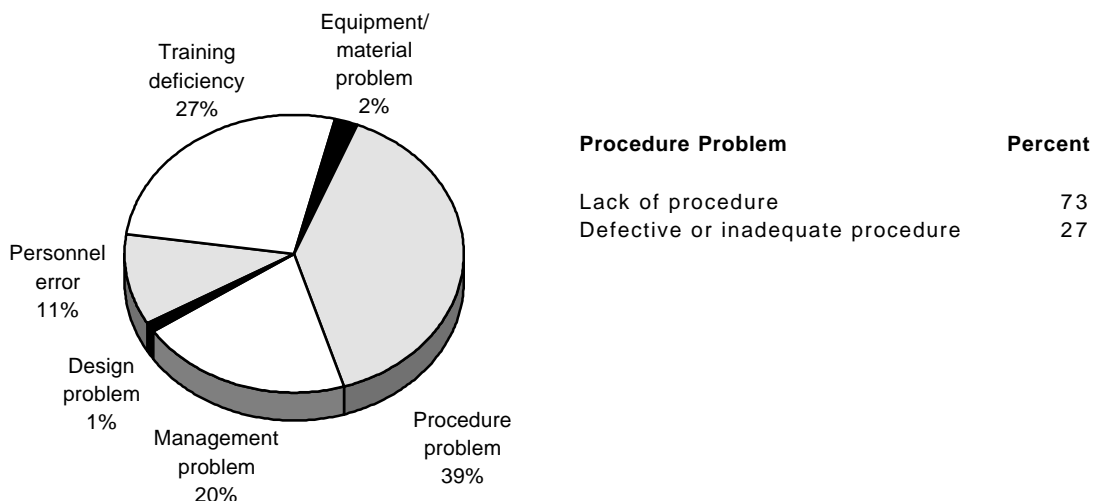
Figure 1-1. Distribution of Root Causes for Occurrences with a Direct Cause of Insufficient Practice or Hands-On Experience¹

Operating Experience Analysis and Feedback (OEAF) engineers reviewed the Occurrence Reporting and Processing System (ORPS) database for occurrence reports with a direct cause of insufficient practice or hands-on experience across the DOE complex and found 94 reports. Figure 1-1 shows that facility managers reported procedure problems as the root cause for 39 percent of the occurrences. They also reported that training deficiencies accounted for 27 percent of the occurrences and management problems for 20 percent. Further review shows managers reported 73 percent of the procedure problems as lack of procedure.

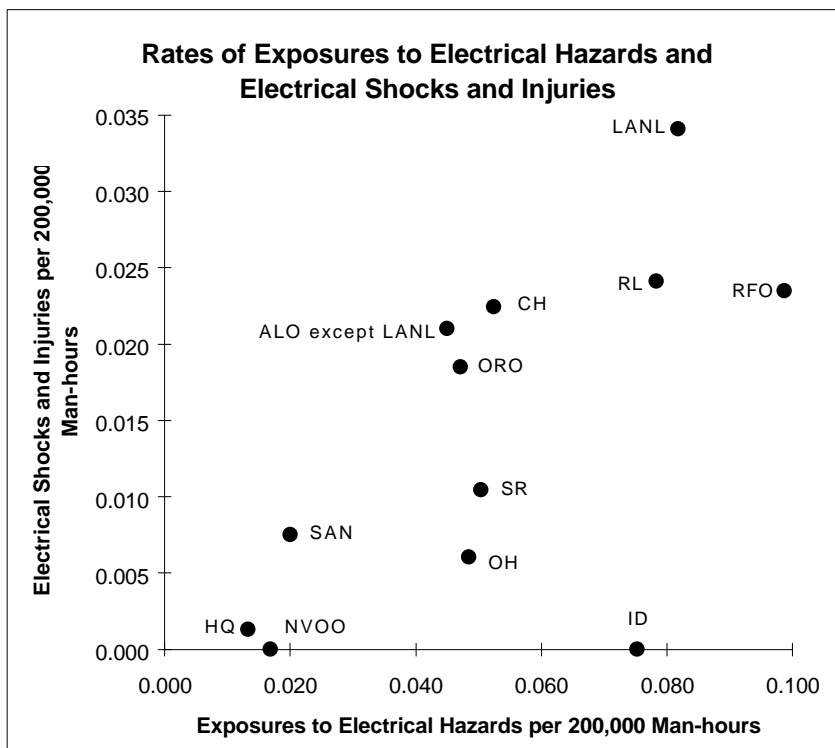
Figure 3-1. Rates of Exposures to Electrical Hazards and Electrical Shocks and Injuries¹

Operating Experience Analysis and Feedback (OEAF) engineers reviewed the Occurrence Reporting and Processing System (ORPS) database for incidents involving exposure to electrical hazard using a complex narrative search and discovery dates January 1, 1994 through December 31, 1996. They reviewed all of the reports for applicability and retained only those involving exposure to an electrical hazard. Figure 3-1 shows that as workers are exposed to electrical hazards, electrical shocks and injuries increase. There is a moderate, but significant, correlation between the rate of exposures and the rate of shocks and injuries. About 30 percent of DOE exposures lead to a shock or injury.

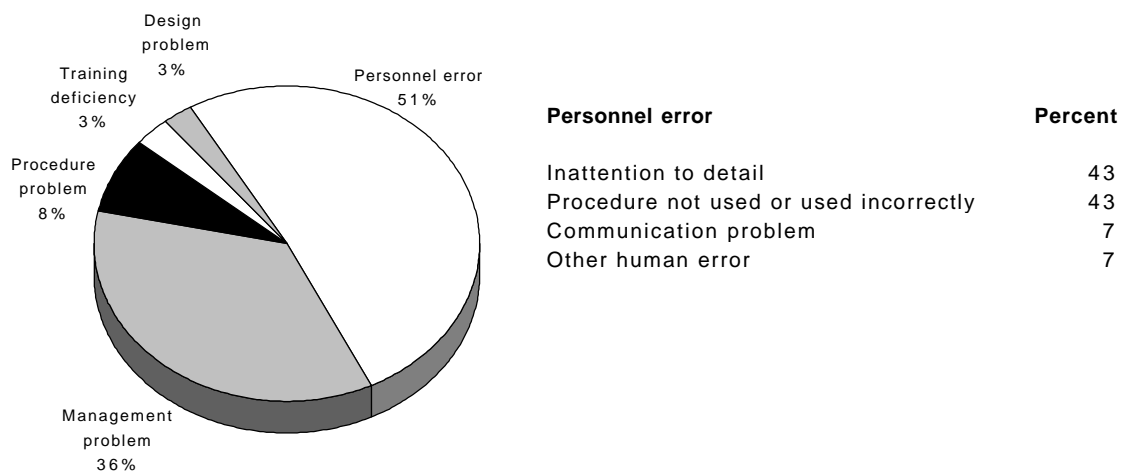
Figure 4-1. Distribution of Root Causes for Procedure Violations¹

Operating Experience Analysis and Feedback (OEAF) engineers reviewed the Occurrence Reporting and Processing System (ORPS) database for procedure violations and found 497 final occurrences. Figure 4-1 shows facility managers reported personnel errors as the root cause for 50 percent of procedure violations across the DOE complex over the last 12 months. Further review shows that 43 percent were reported as inattention to detail and 43 percent were reported as procedure not used or used incorrectly.

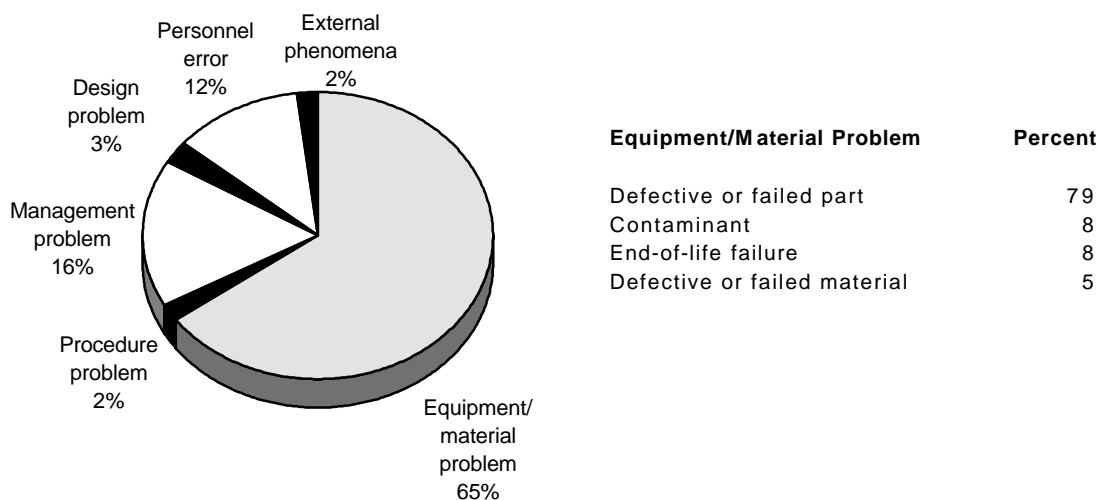
Figure 6-1. Distribution of Root Causes for Unsatisfactory Surveillance/Inspections¹

Operating Experience Analysis and Feedback (OEAF) engineers reviewed the Occurrence Reporting and Processing System (ORPS) database for unsatisfactory surveillances and inspections across the DOE complex and found 152 occurrences for the last 12 months. Figure 6-1 shows that facility managers reported equipment/material problems as the root cause for 65 percent of the occurrences. They also reported that management problems accounted for 16 percent and personnel errors accounted for 12 percent of the occurrences. Further review shows that 79 percent of the equipment/material problems were reported as defective or failed parts.
